**SUBJECT: Response to PA DEP and East Rockhill Township Comments  
Qualitative Geologic Survey Sampling Plan  
Rock Hill Quarry, SMP No. 7974SM1  
East Rockhill Township, Bucks County, PA  
EARTHRES Project No. 061003.051**

## **Figure 1 – Geologic Features and Coring Location Plan**

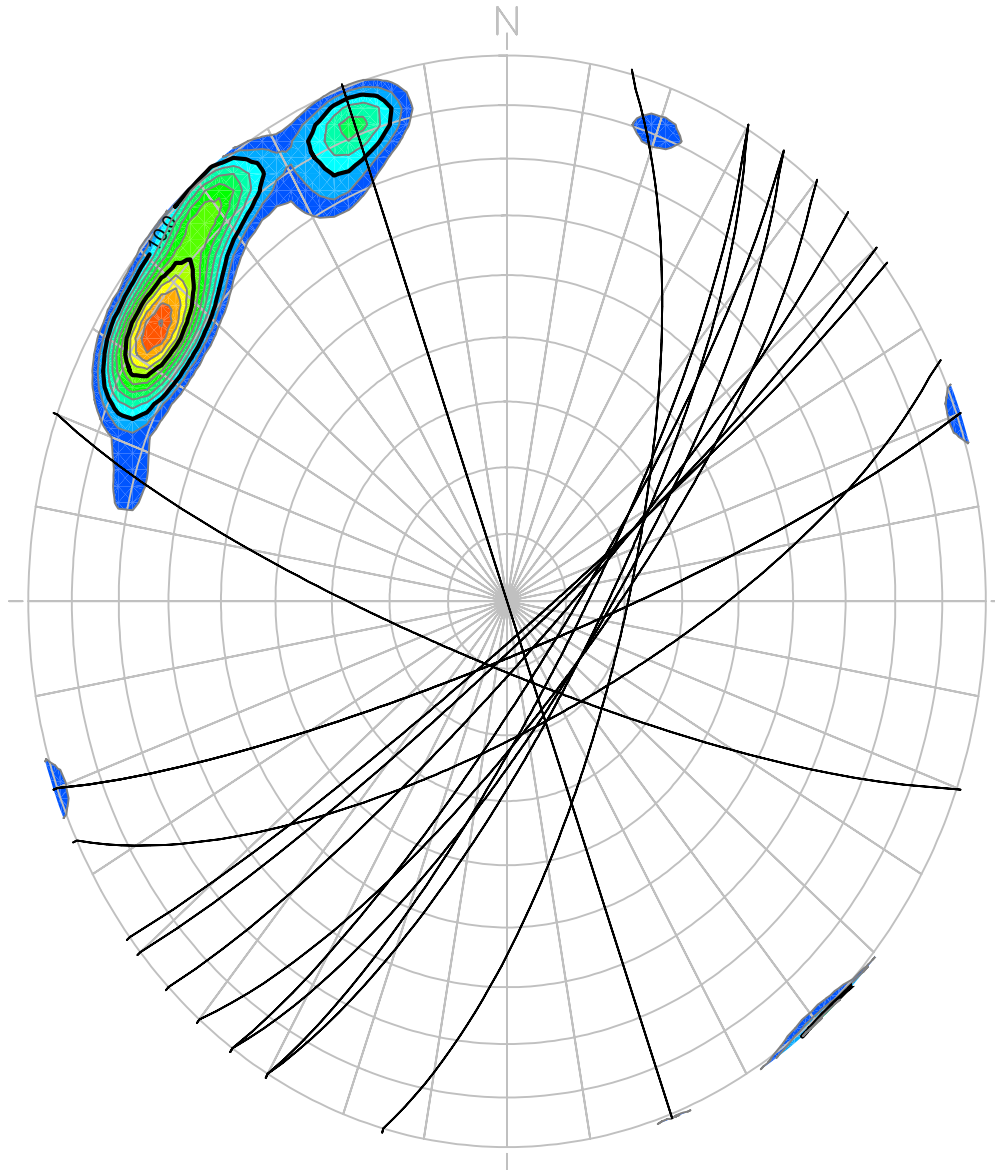
# Rock Hill Quarry - Bench Mapping

Statistical Summary	
Projection:	Schmidt (Equal Area)
Number of Sample Points:	14
Mean Lineation Azimuth:	314.7 <b>N44.7E</b>
Mean Lineation Plunge:	12.1 <b>77.9 SE</b>
Great Circle Azimuth:	227.9
Great Circle Plunge:	12.1
1st Eigenvalue:	0.814
2nd Eigenvalue:	0.178
3rd Eigenvalue:	0.007
LN ( E1 / E2 ):	1.518
LN ( E2 / E3 ):	3.17
(LN(E1/E2)] / (LN(E2/E3)):	0.479
Spherical Variance:	0.1178
Rbar:	0.8822

*Please find the attached table that includes the geological data (i.e. strike, dip, and description) of the bench-face features found during the on-site mapping completed on April 22, 2019. The data was statistically analyzed using Rockworks software to determine the average strike and dip of the features. A stereonet plot of the data is attached and indicates an average strike of the vein features to be N45E, dipping steeply at 78 degrees SE. The average feature strike is in agreement with the regional strike direction indicated the QGSSP submitted on April 3, 2019. Also provided herein are photographs of the mapped features that are keyed to their locations on each bench (Drawing D-1: Bench Face Mapping). The data was further plotted in 3D using AutoCAD to evaluate feature trends with respect to the proposed drilling locations.*

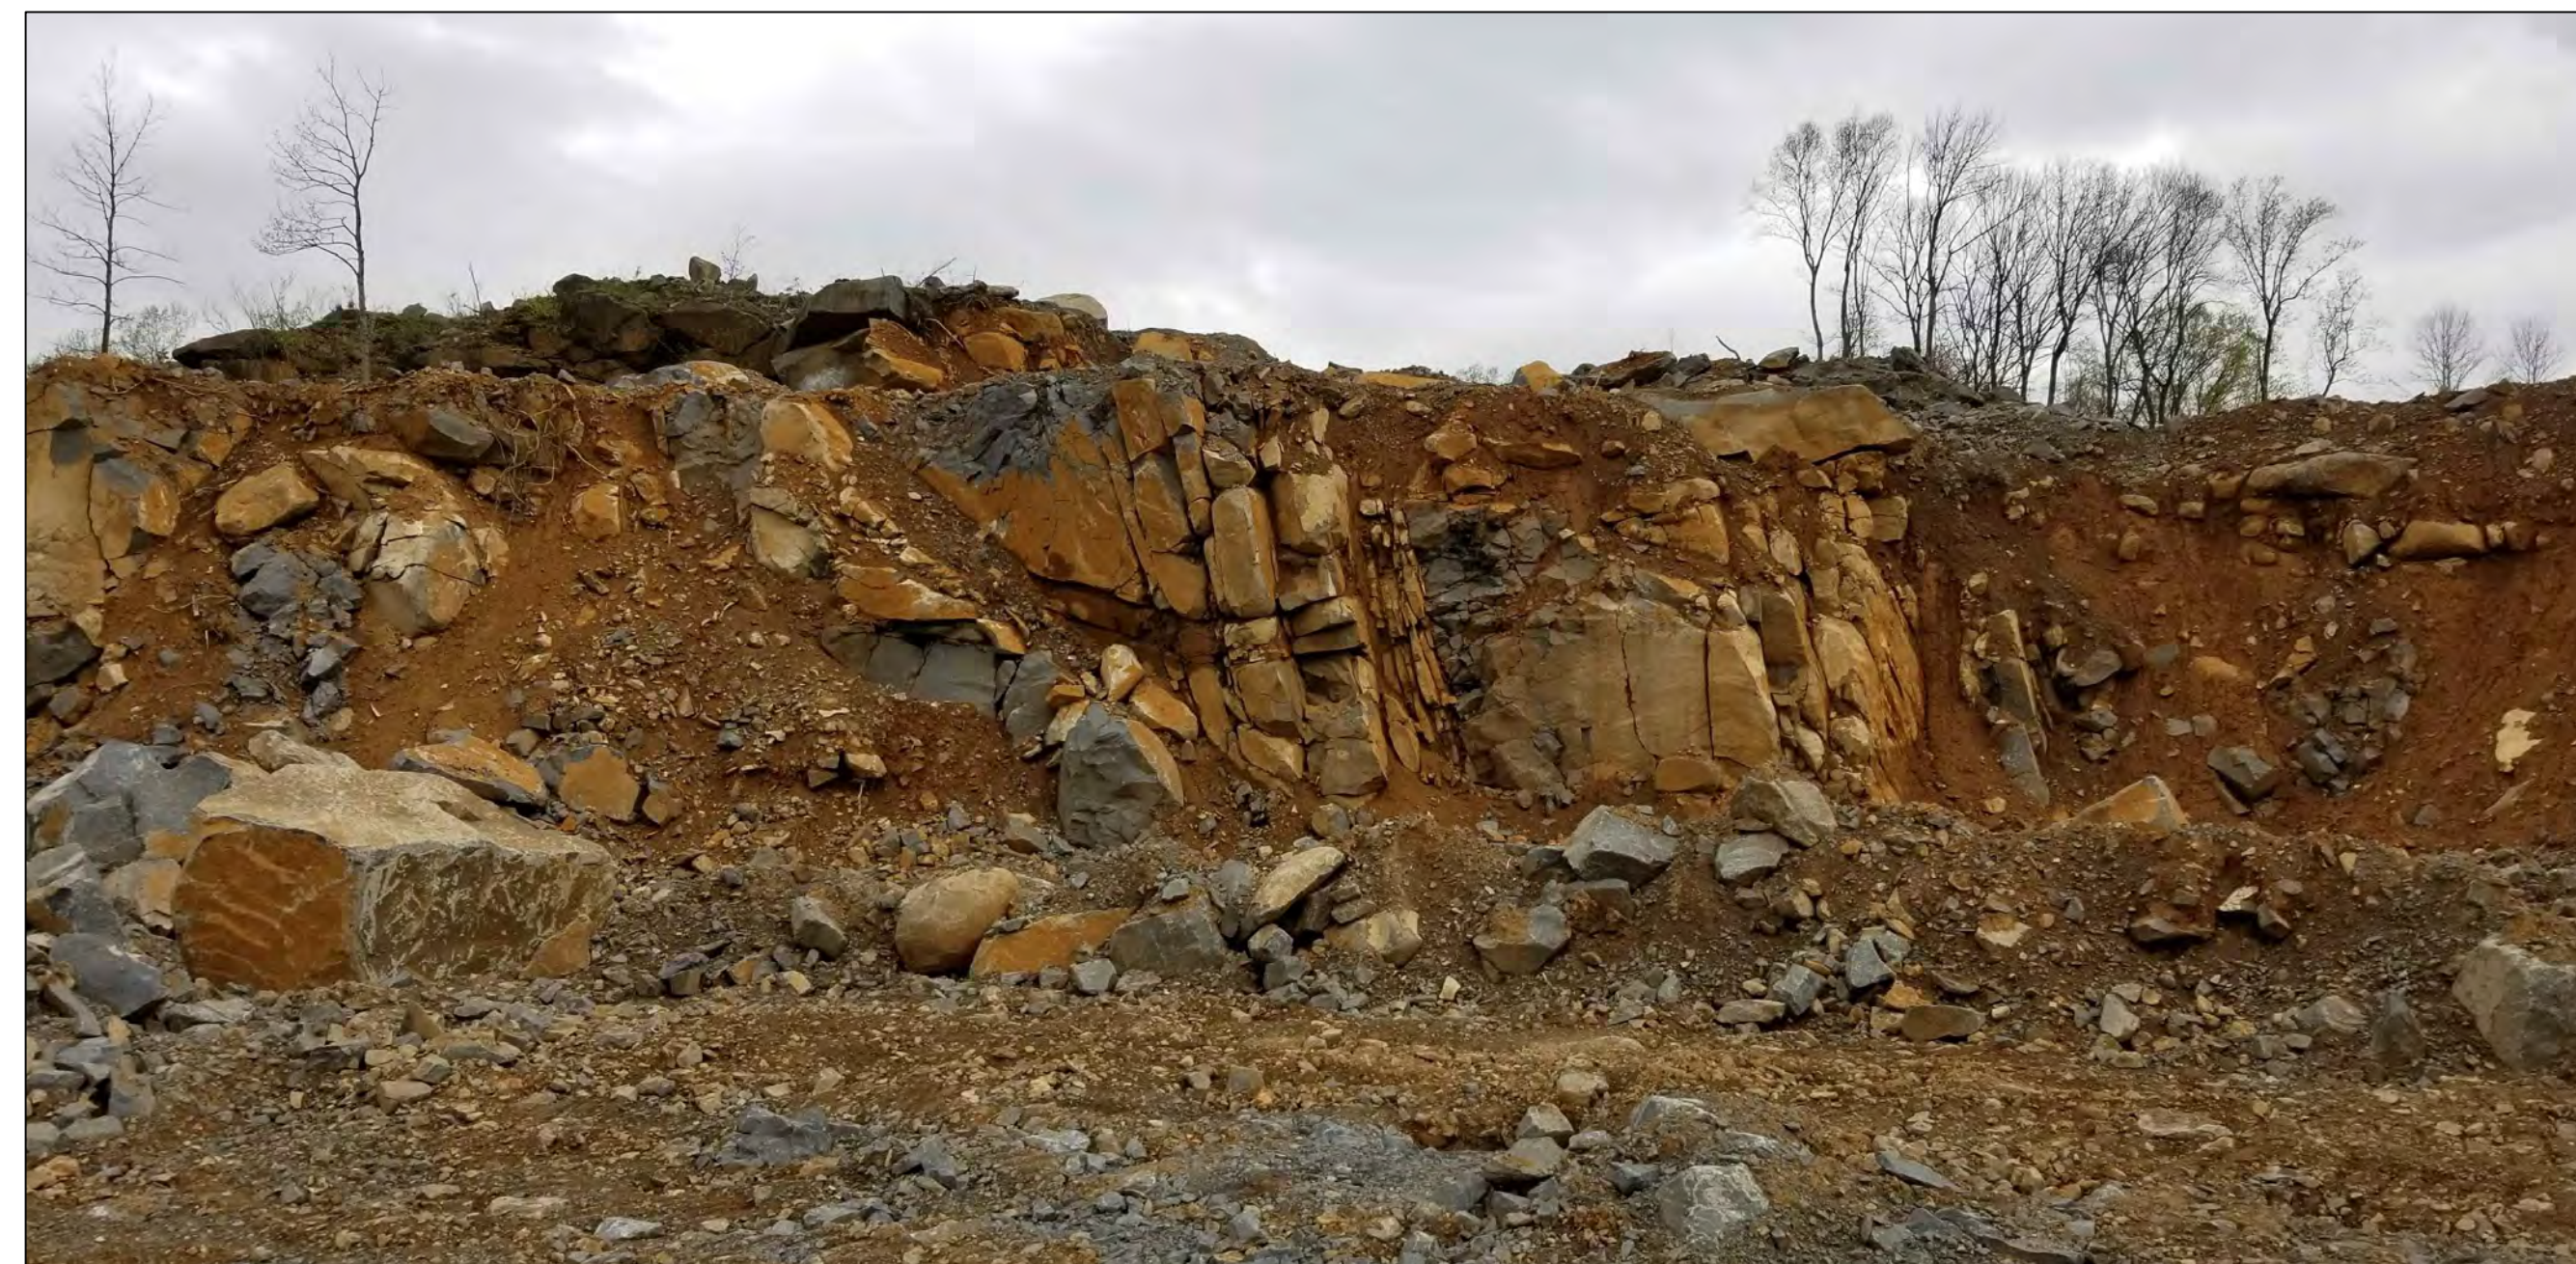
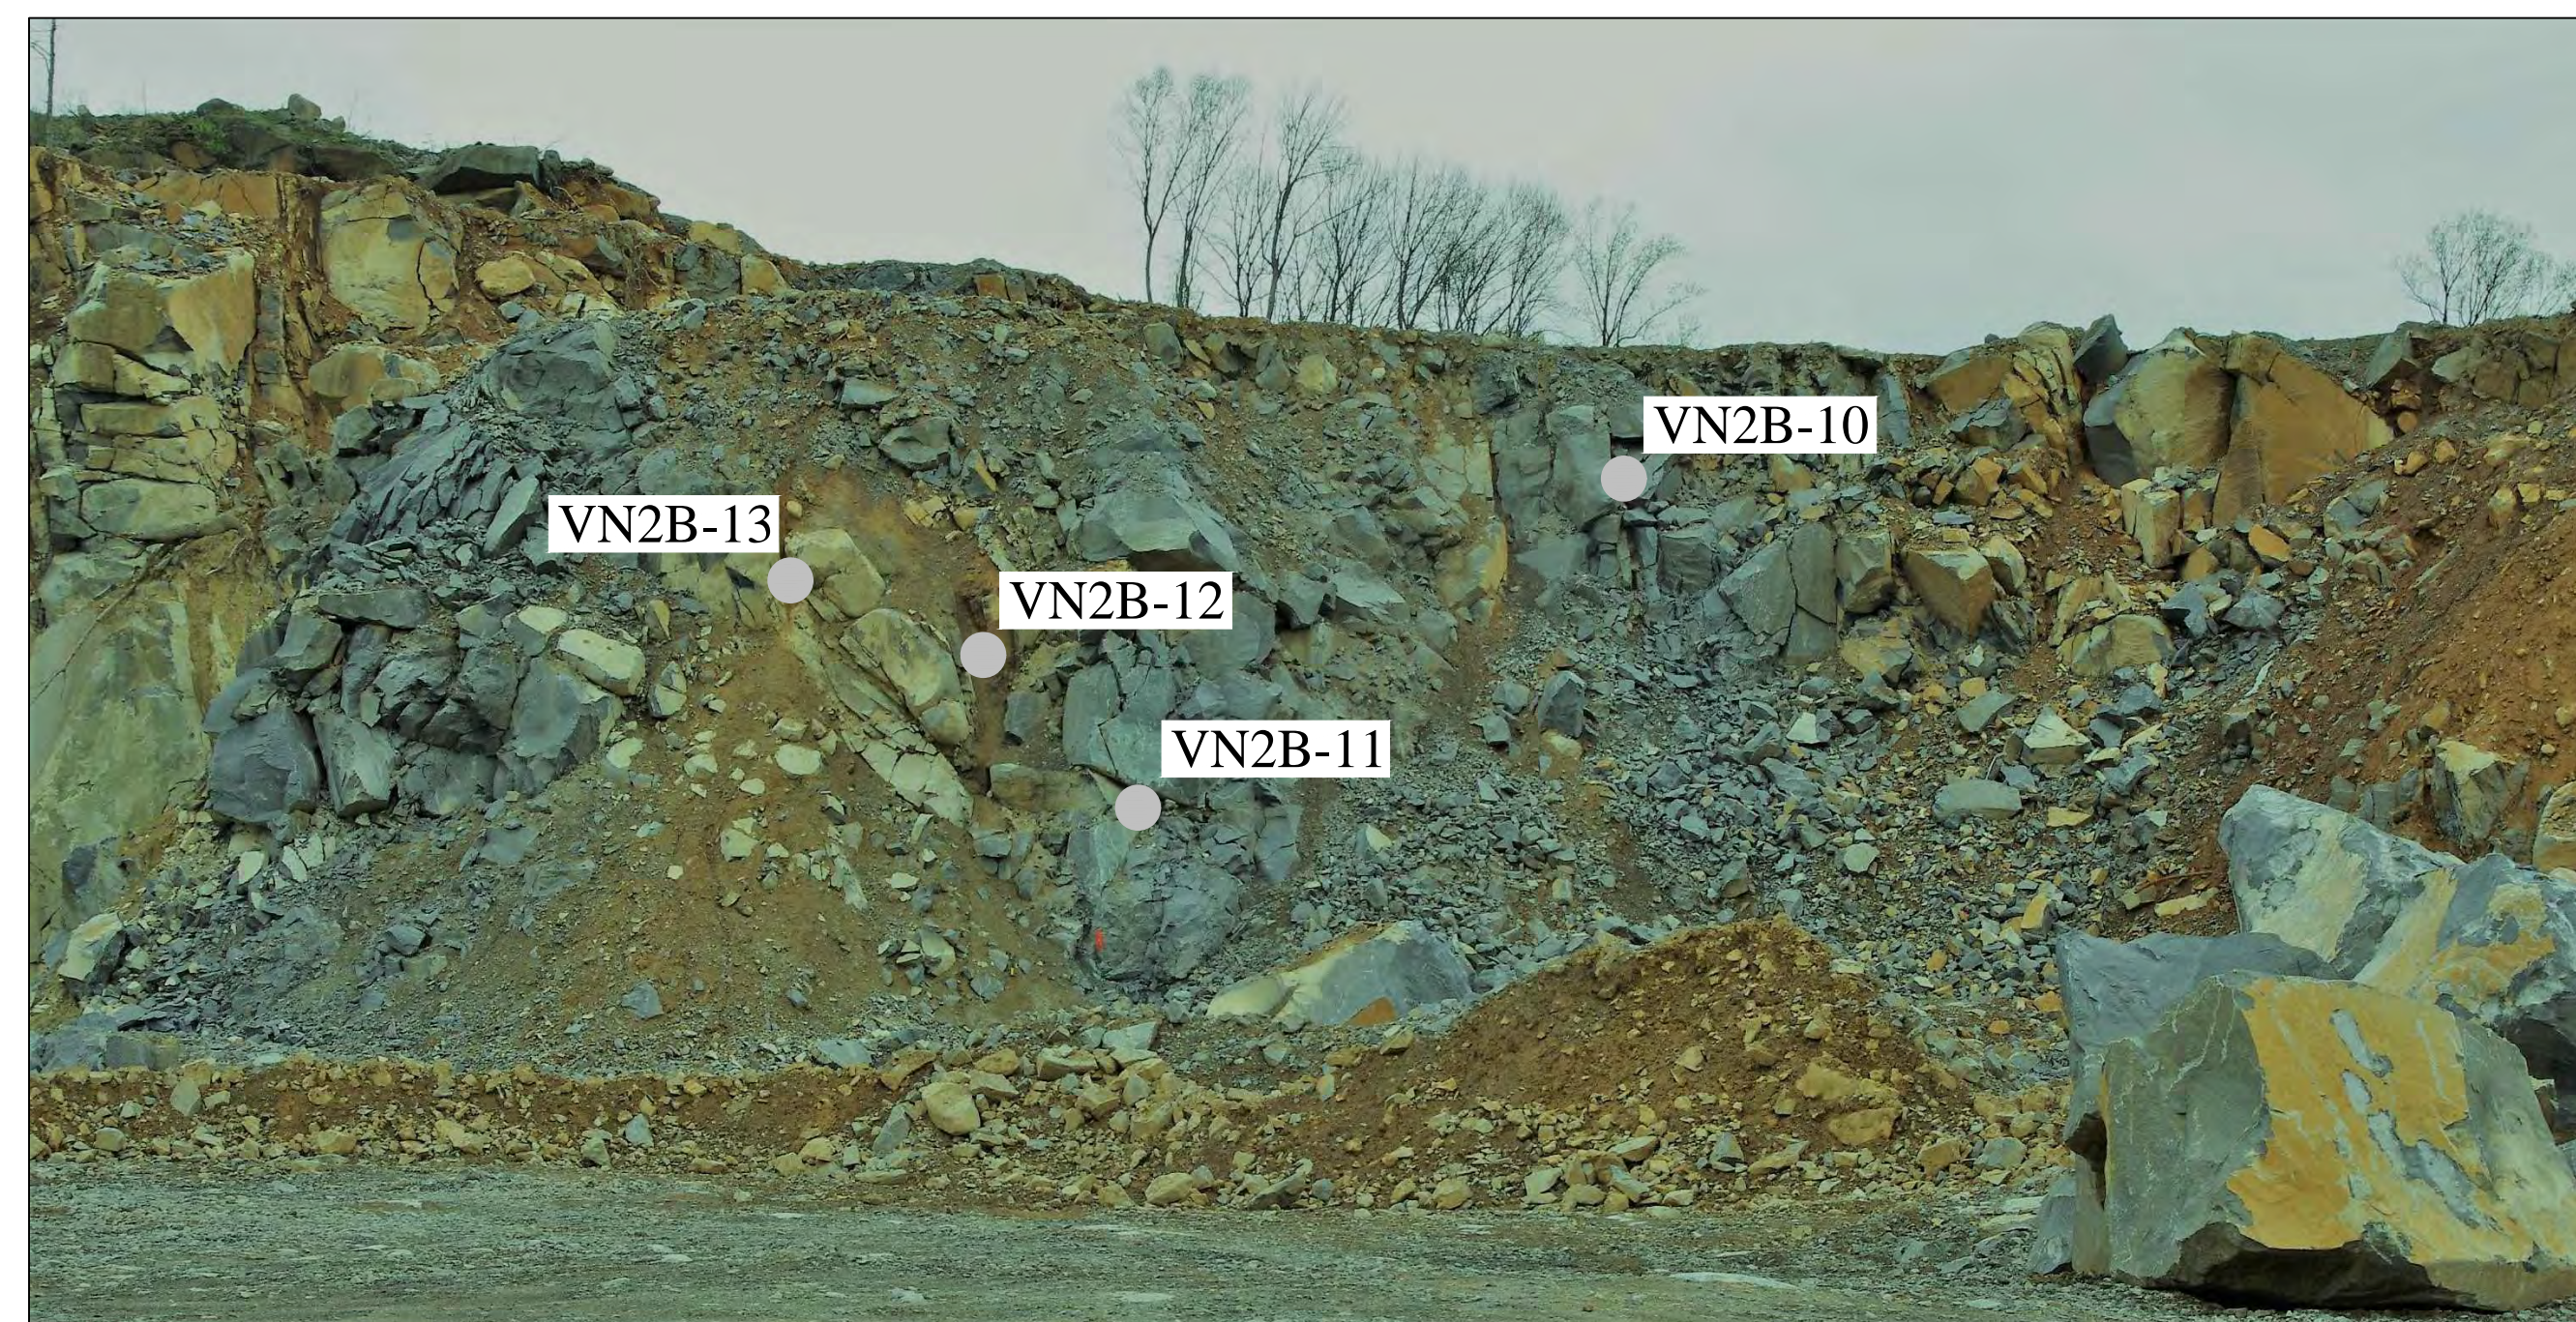
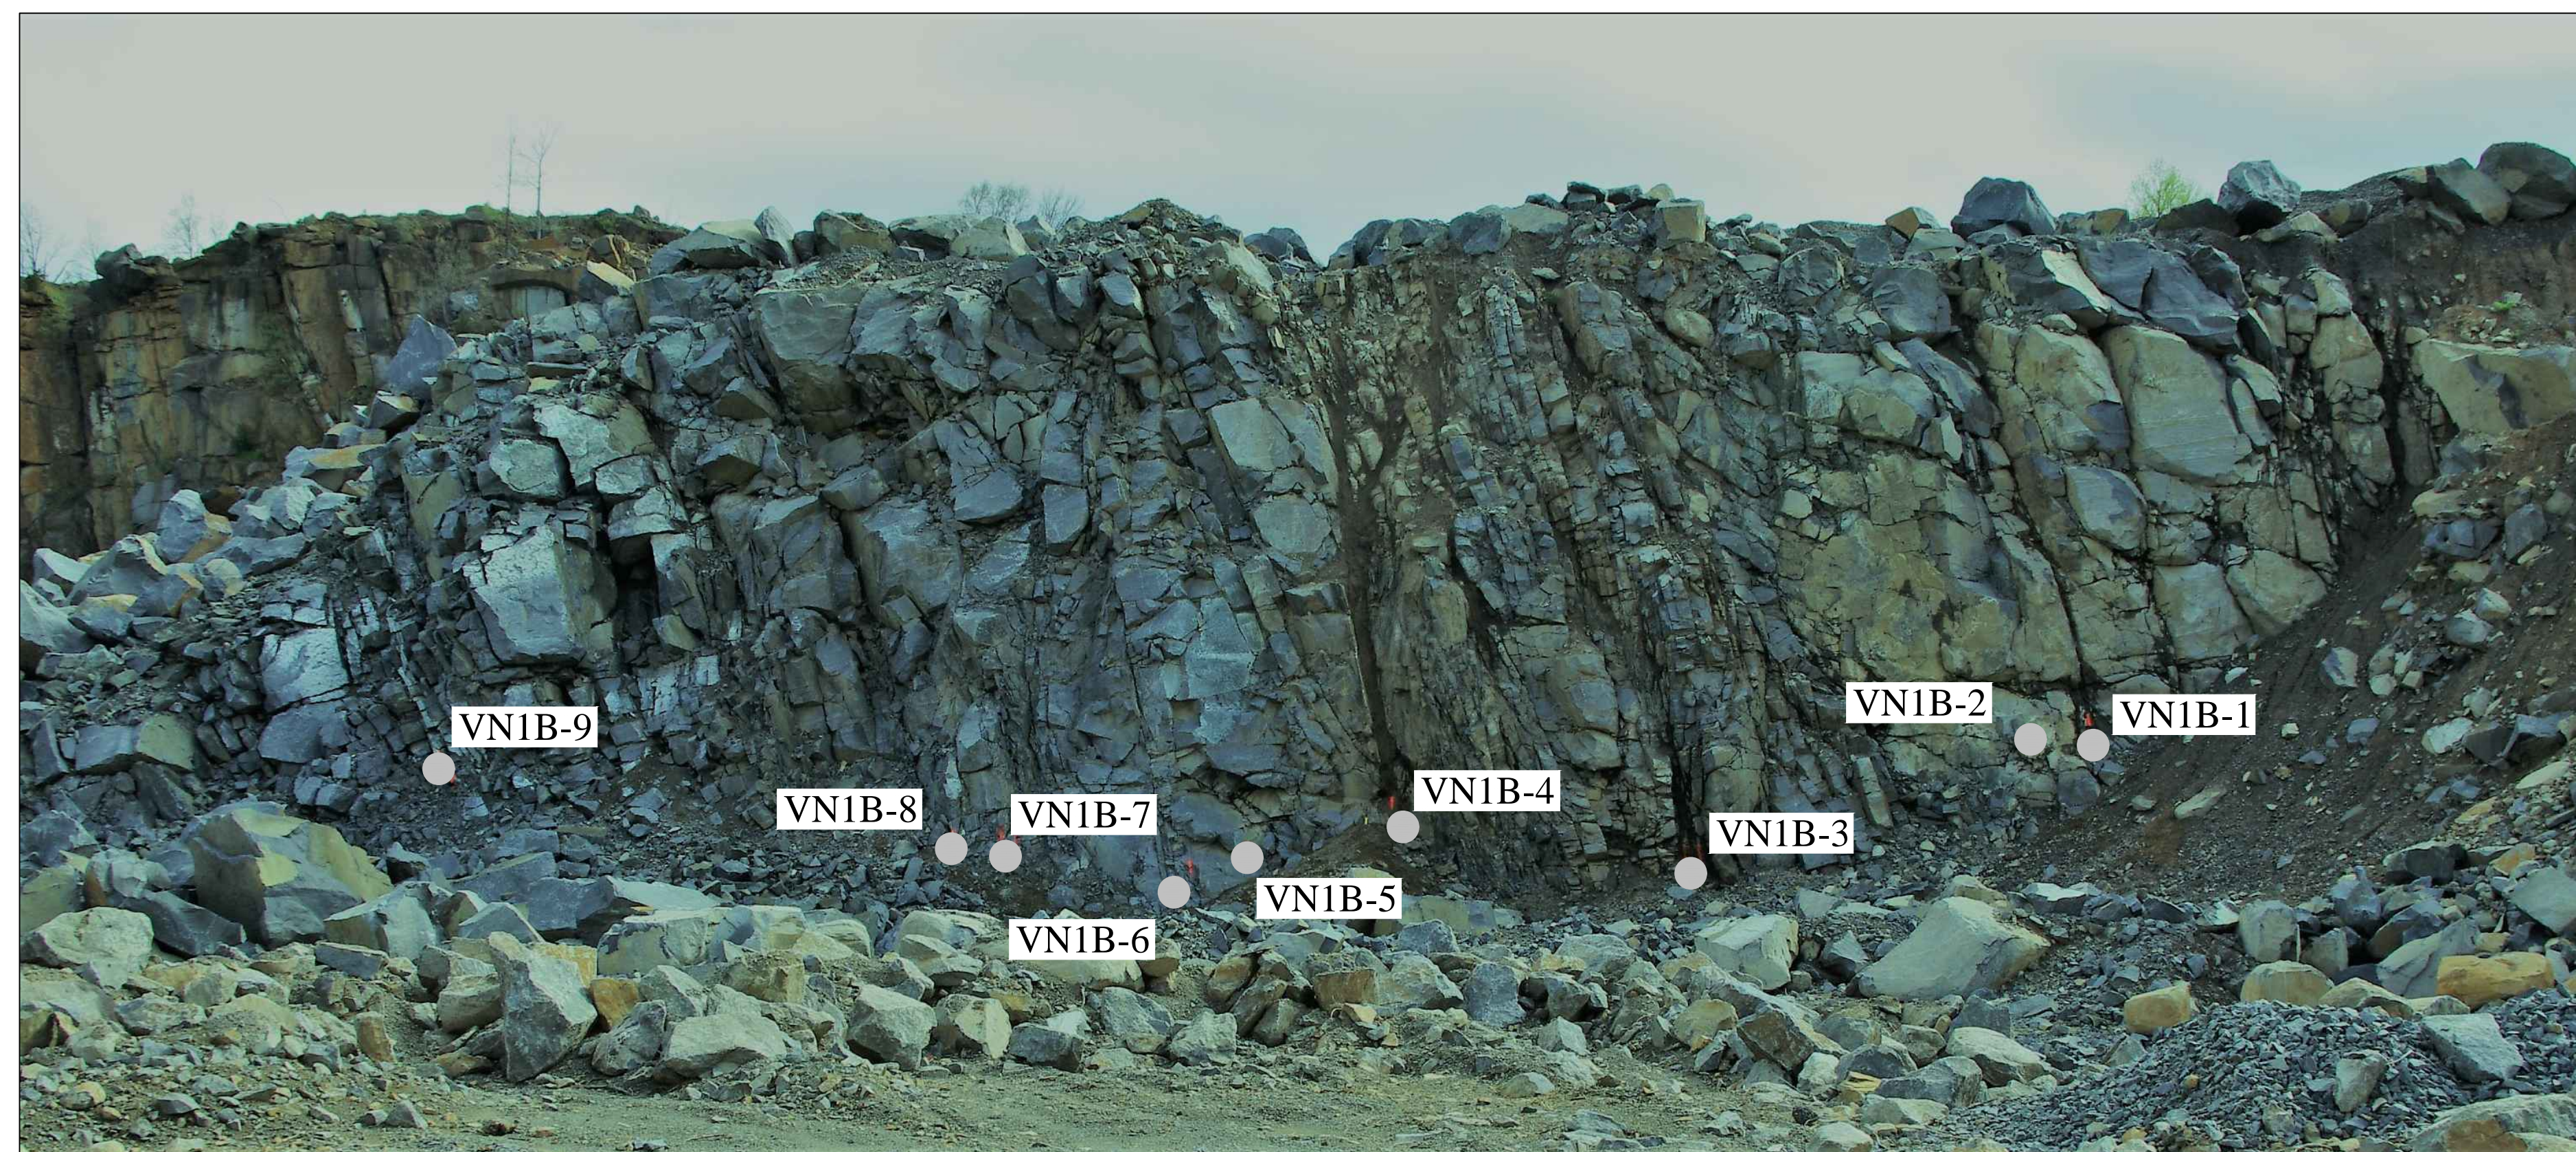
# Drawing D-1: Bench Face Mapping

### BENCH 3 FACE

### BENCH 2 FACE (VN2B)

### BENCH 1 FACE (VN1B)

*EARTHRES and Hanson professional geologists were onsite Monday April 22, 2019 to map mineral vein features exposed on the benches proposed for drilling and ultimately mining activities. The results of that effort are attached to these responses. Overall, the features found were trending as expected provided the geological environment, the geological evaluation contained in our report of January 2018, our QGSSP dated April 3, 2019 and our prior comment responses of April 17 and 19, 2019. Additional detailed responses to your questions are provided in the following comment responses and in the attached documents.*

Vein ID	Strike	Dip	Photo Time	Description
1	N40E	75SE	8:31	4" to 6" wide weathered zone; no mineral veining visible.
2	N20W	90	8:44	Whitish, thin coating on diabase sub-parallel to wall face.
3	N52E	85SE	8:44	8" to 1.5' wide weathered fault/shear zone; whitish undulating mineral veining noted, green color noted at top of zone.
4	N64E	71SE	8:51	Approx. 8" wide brown highly weathered; whitish undulating mineral veining noted.
5	S80E	80SW	8:59	Whitish, very thin coating on diabase trending oblique to wall face.
6	N50E	84SE	9:02	Approx. 0.5" white haloed, dark colored vein.
7	N70E	82SE	9:08	Approx. 8" wide weathered vein; apparent Actinolite vein; green elongated flattened crystals; appears to pinch out further up the wall.
8	N30E	78SE	9:17	Approx. 0.5" white haloed, dark colored vein.
9	N15E	70SE	9:28	Approx. 4" wide banded white/greenish mineral vein.

Vein ID	Strike	Dip	Photo Time	Description
10	N35E	80SE	10:04	South side of wall, white vein visible near top of wall; estimated narrow 1" vein.
11	N70E	82SE	10:10	Approx. 0.5" white vein, continuous trending up wall.
12	N30E	75SE	10:14	Approx. 8" to 12" mud vein, discontinuous in upper and lower wall due to weathering and talus; no white veins visibly noticeable.
13	N45E	82SE		Approx. 4" to 8" mud vein, located several feet north on wall from above Vein #3; discontinuous in upper and lower wall due to weathering and talus; central discolored white vein noticeable.

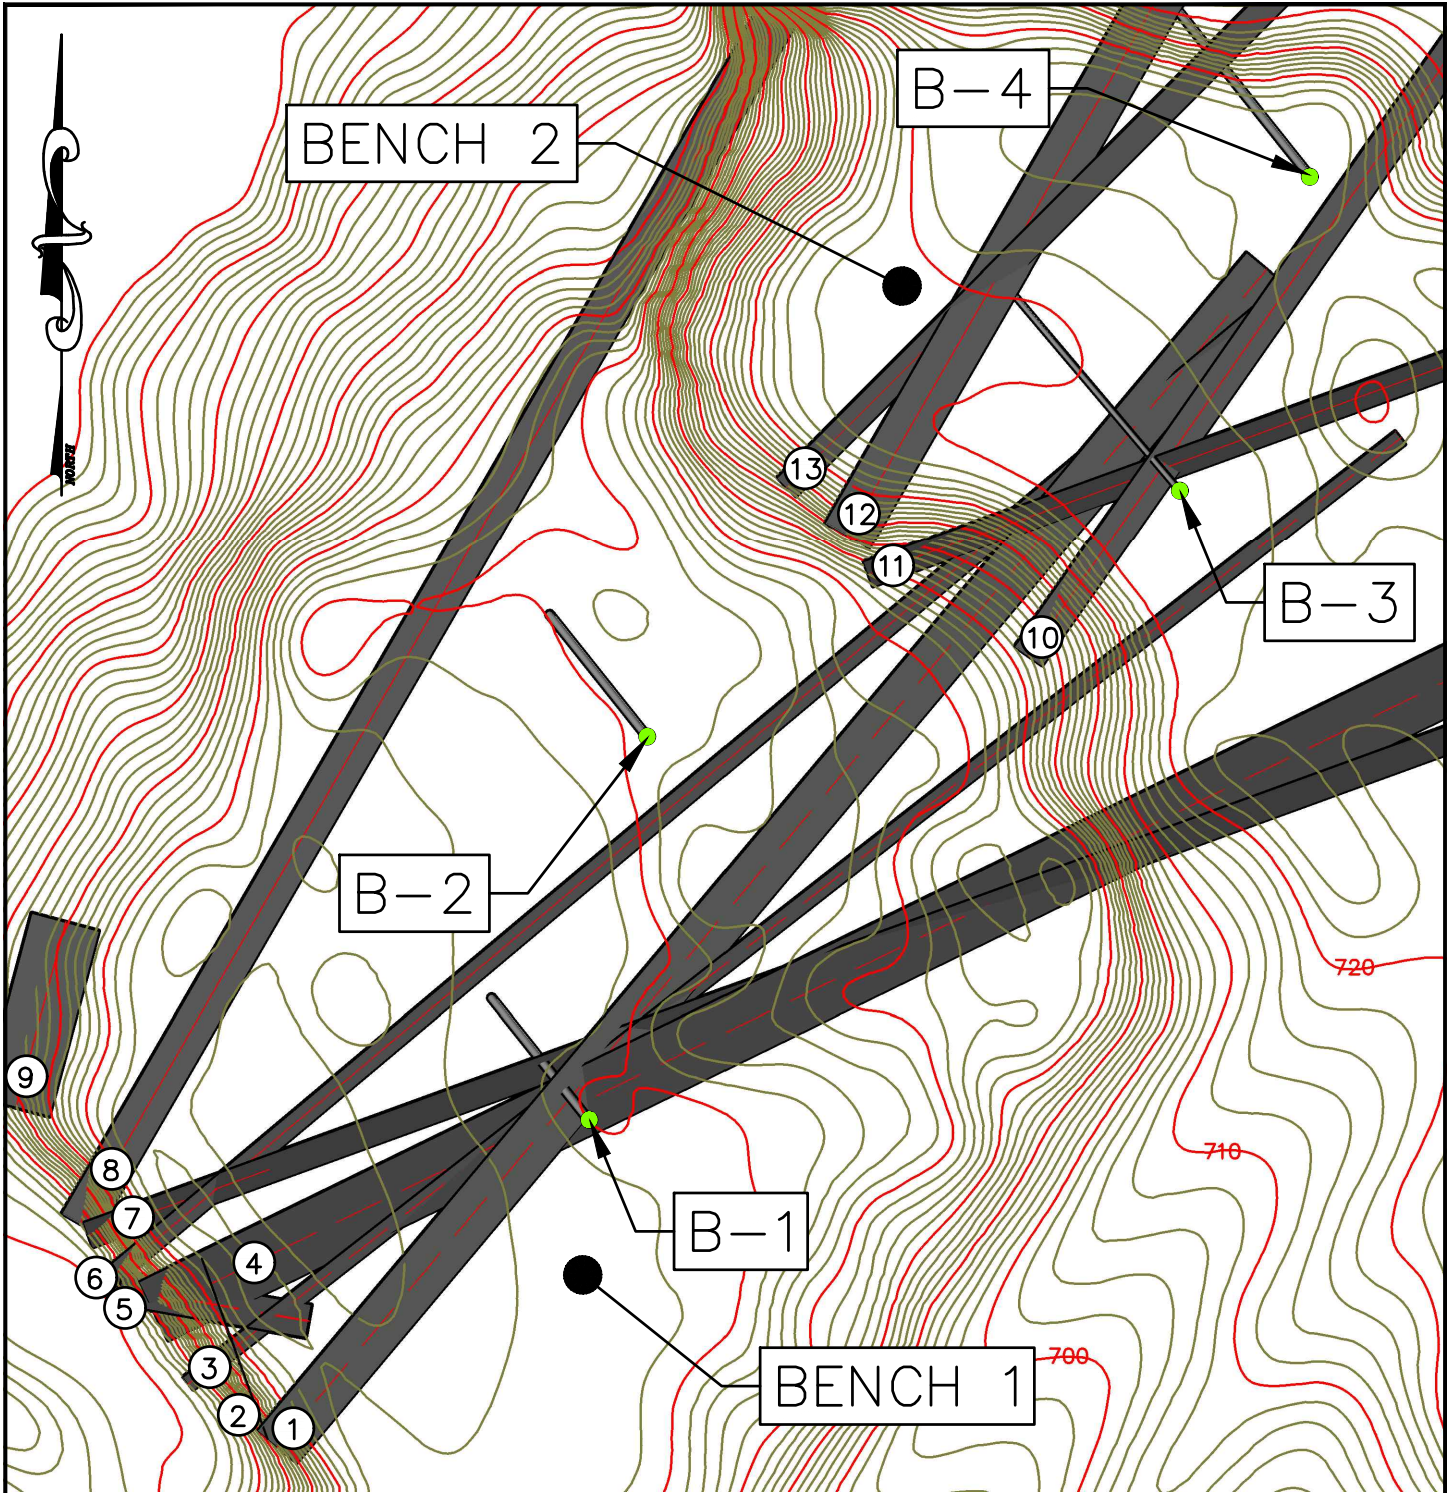
**FIGURE 1**  
GEOLOGIC FEATURES AND BORING LOCATION PLAN

BORINGS ARE MADE AT STRIKE N45W, DRILLED AT 30° FROM VERTICAL.

*The proposed coring locations and mapped features are shown in map view on the attached Figure 1. The cores will be drilled on an approximately 30-degree angle from vertical with an azimuth of approximately N45W. The drilling direction is oriented perpendicular to geological strike and is dipping opposite of the found features in order to intercept as many potential features as practical. The core borings will be advanced to an elevation of approximately 585 feet above mean sea level (MSL), which is approximately equivalent to the current water level in the Quarry pit.*

*Core Borings 1 (B-1) and B-2 are proposed to be located on Bench 1. The B-1 location was chosen to intercept the Veins 1, 3, 4, and 7. Coring B-2 is proposed in an area where face-mapped features are not projected to be present, thus providing additional geological coverage.*

*Core Borings B-3 and B-4 are proposed to be located on Bench 2. The B-3 location was chosen to intercept the Veins 1, 6, 10 and 11. B-4 is proposed to intercept Veins 12 and 13 and provide additional geological coverage in an area where face-mapped features are not projected to be present.*
