**Re: Rock Hill Quarry NOA Monitoring Plan
SMP No. 7974SM1
East Rockhill Township
Bucks County, Pennsylvania**

**EarthRes January 18, 2018
Asbestos Investigation Results Report**

**SUBJECT: Asbestos Investigation Results
Rock Hill Quarry Operation
SMP No. 7974SM1
East Rockhill Township, Bucks County
EarthRes Project No. 061003.051**

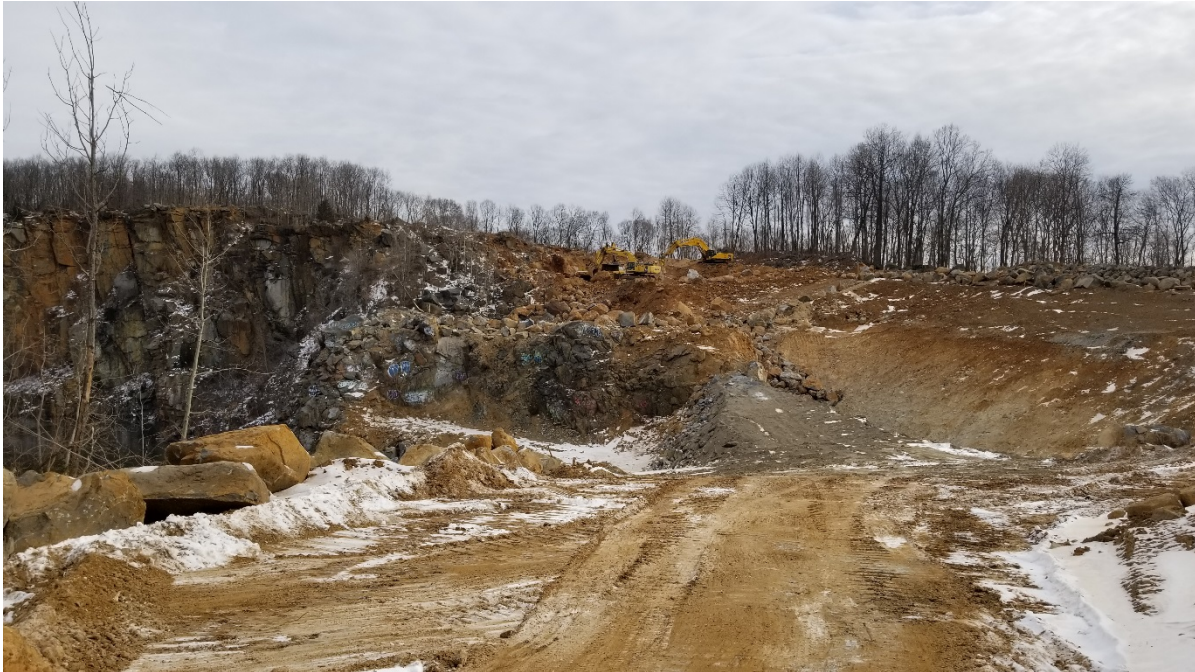
Southern Quarry Working Area

The site is an existing permitted mine located on the western side of Rock Hill. Currently, the southern portion of the mine is being prepared for additional mining of the diabase bedrock. Site preparations include overburden removal and drilling of test holes for sampling and production blasting. However, per the Department's January 4, 2018 letter and directive, production drilling, blasting, and crushing has ceased.

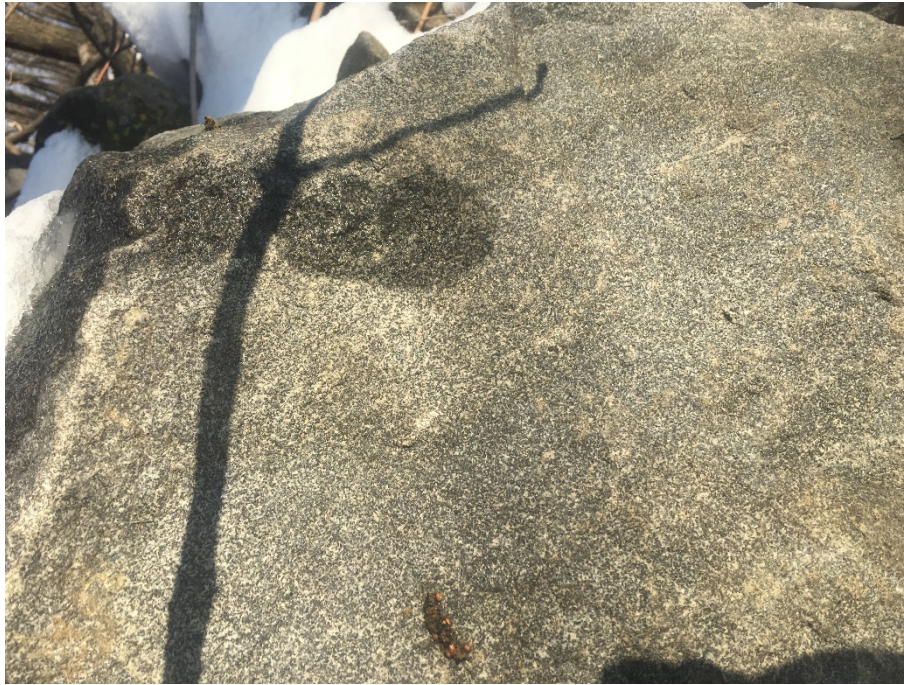
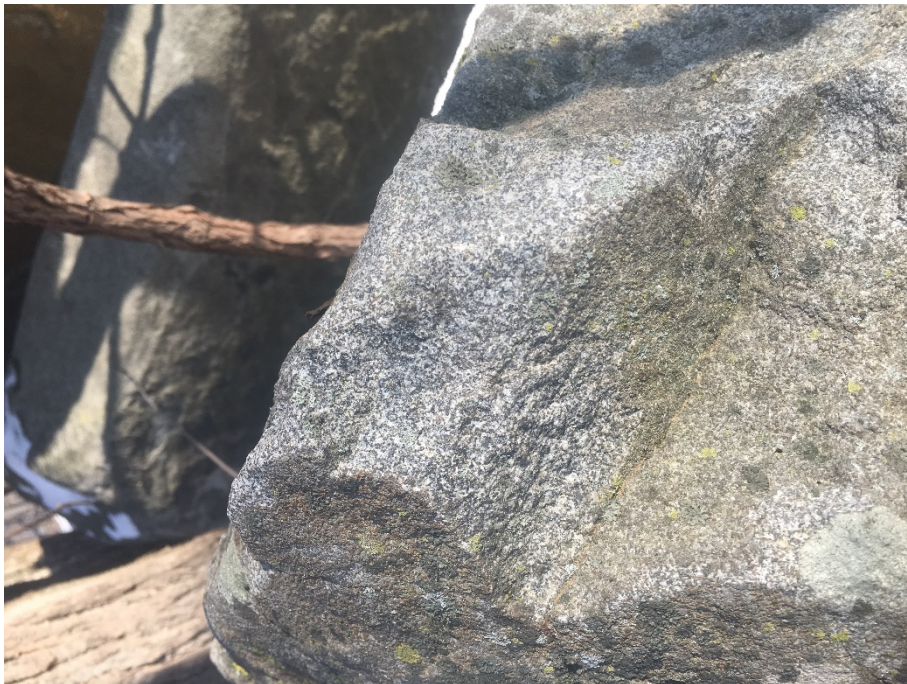
Typical Diabase Boulder

Numerous large boulders were assessed on the southern, northern, and eastern sides of the site. Freshly-broken surfaces were visually inspected to identify the potential presence of naturally occurring asbestos NOA. Each boulder observed consisted of a tightly-massed, fine to medium grained crystalline diabase. Joints were observed to be weathered and typically covered by an oxide, typically manganese or ferric oxide. Mineral veining containing potential NOA was not observed in the examined boulders. Four (4) mineral veins were observed on the southern highwall adjacent to the proposed mining area and were sampled as described in the preceding paragraph.

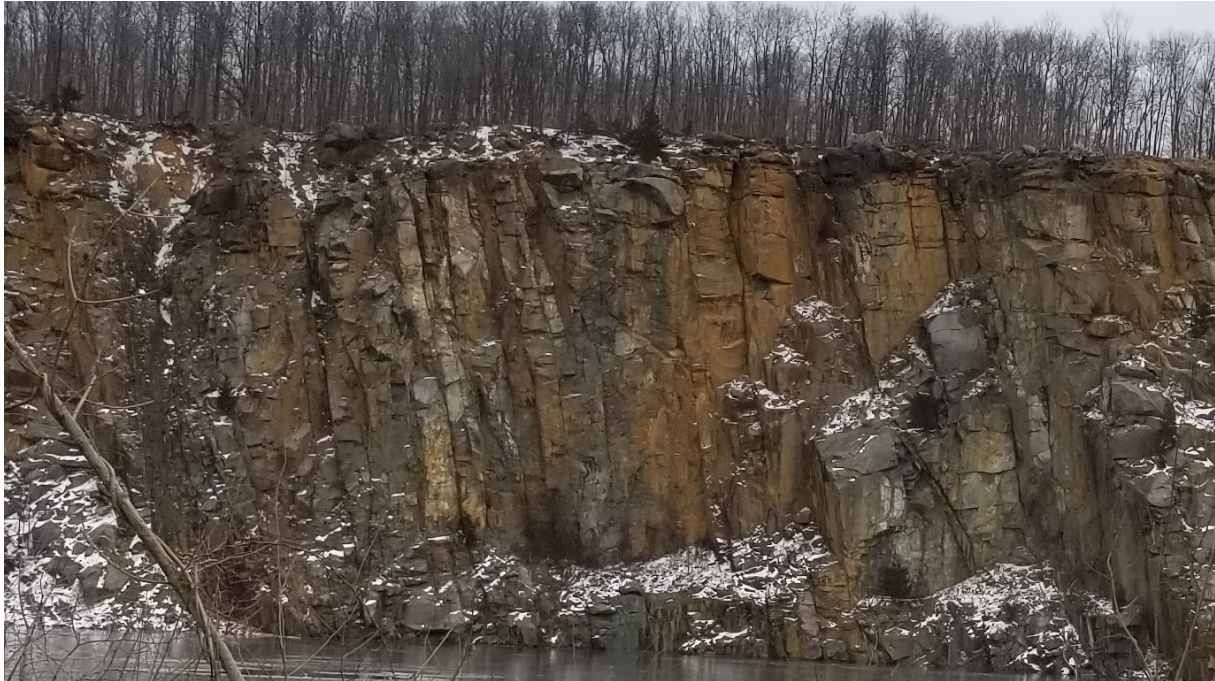
Eastern Highwall Diabase

Sedimentary rocks or features (e.g. bedding, folds, cross-beds, etc.) were not visually observed on the highwalls. Near-vertical jointing was observed along much of the eastern highwall. Contacts with sedimentary host rocks were not indicated in the surrounding outcrops or boulder fields. Several photographs taken onsite are included in Appendix C showing field conditions at the time of mapping. The investigation area is indicated to be wholly within the diabase bedrock.

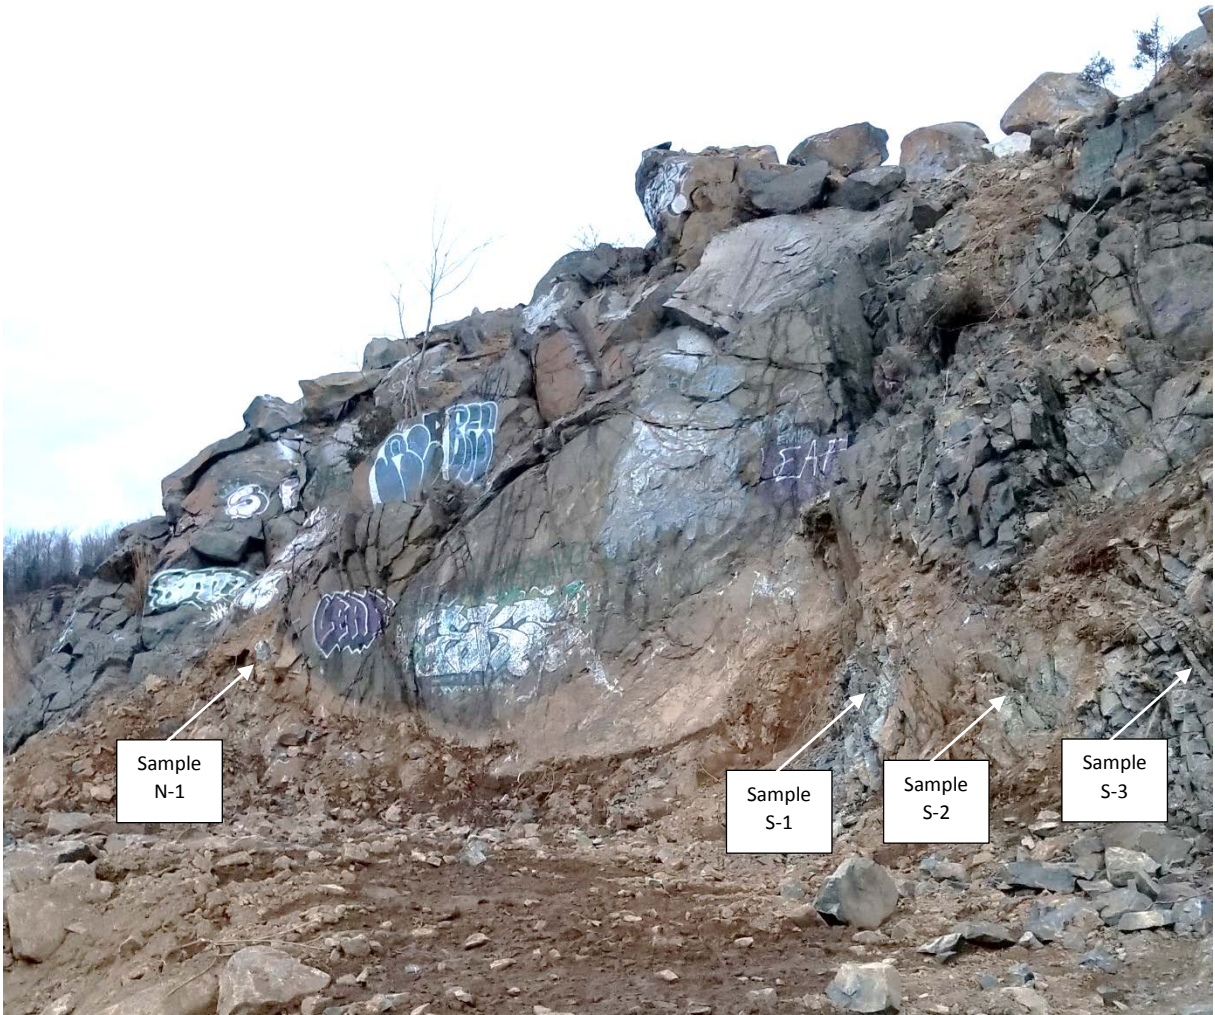
LOCATION OF SAMPLING

Outcrop hand samples of observed mineral veining from the southern highwall were collected and numbered (from north to south): N-1, S-1, S-2 and S-3, as the highwall in the area of the sampling trends approximately north-south. The general sampling location is shown on the attached Figure in Appendix A. Pictures of the highwall, specific sampling locations and the collected sampled are provided in the photographs in Appendix C.

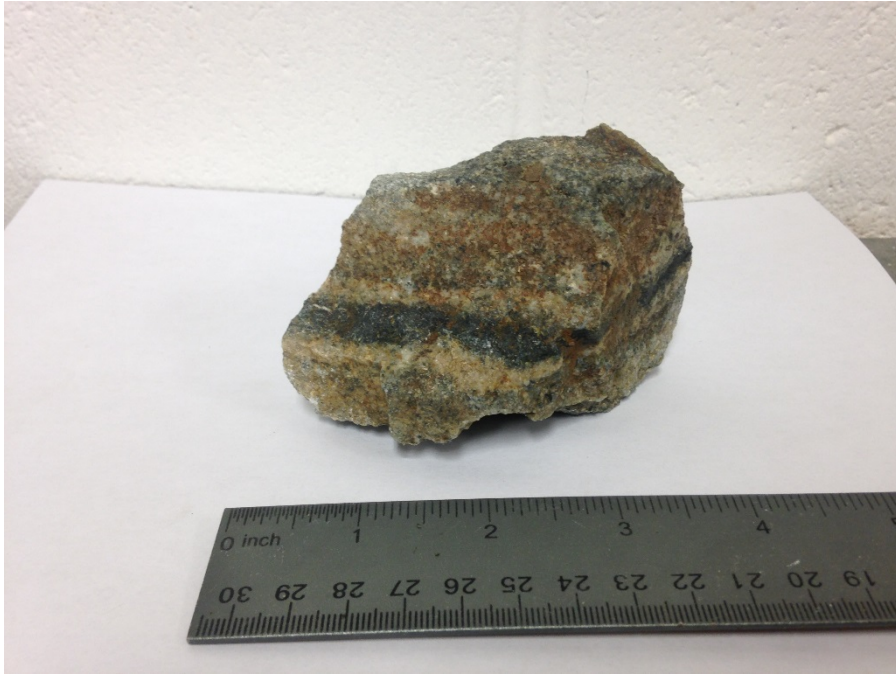
SAMPLE N-1

Sample	Description	Appearance	Non-Asbestos		Asbestos
			% Fibrous	% Non-Fibrous	% Type
N-1 041800978-0001	Rock Sample	Gray Non-Fibrous Homogeneous		100% Non-fibrous (Other)	None Detected
S-1 041800978-0002	Rock Sample	Gray Non-Fibrous Homogeneous		100% Non-fibrous (Other)	None Detected
S-2 041800978-0003	Rock Sample	Gray Non-Fibrous Homogeneous		100% Non-fibrous (Other)	None Detected
S-3 041800978-0004	Rock Sample	Gray Non-Fibrous Homogeneous		100% Non-fibrous (Other)	None Detected
